FACILITY INSPECTION REPORT

8365919001	William Koot	Koot Dairy
WDID NUMBER	OWNER NAME	FACILITY NAME
R8-2007-0001	8762 Kimball Avenue	8762 Kimball Avenue
NPDES NUMBER	OWNER ADDRESS	FACILITY ADDRESS
	Chino, CA 91710	Chino, CA 91710
	OWNER CITY AND STATE	FACILITY CITY AND STATE
	William Koot (owner)	Nick Koot
SCHED. INSP. DATE	OWNER CONTACT	FACILITY CONTACT
12/8/2011	(909) 393-1955	(909) 286-1764
ACTUAL INSP. DATE	OWNER PHONE NO.	FACILITY PHONE NO.
	FACILITY LATITUDE: 33.969092	FACILITY LONGITUDE: -117.612594

Koot Dairy

Tetra Tech, Inc. (Tt)

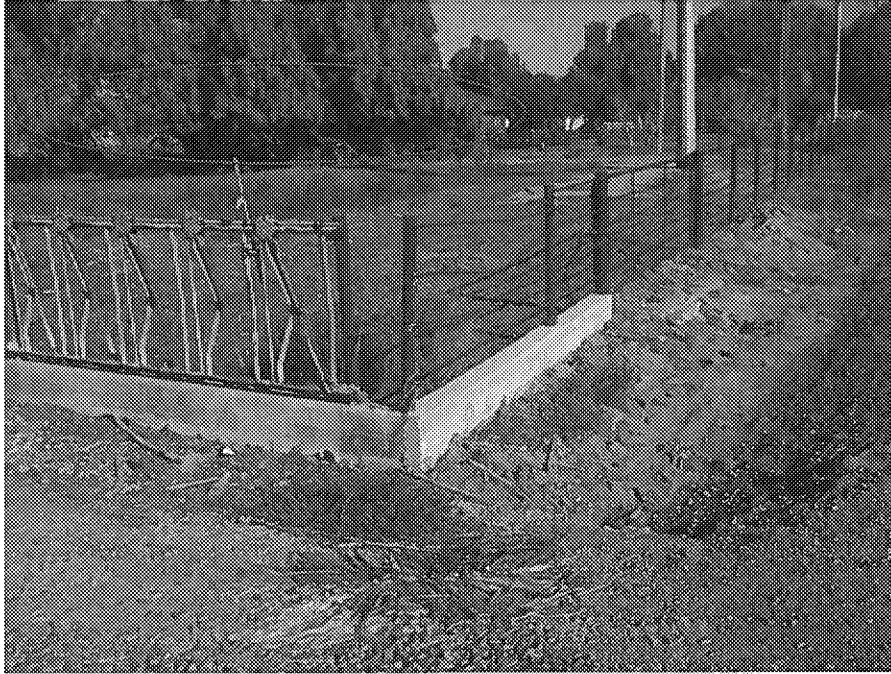
- 1) The EWMP stated that Corrals #9 and #10 need to be regraded to ensure that on-site storm water runoff is contained. Corral #10 appeared to still drain south and away from Lagoon #1 (Photo 3) and Corral #9 was not regraded or contained to prevent runoff to Kimball Avenue (Photo 5).
- 2) Pastures #1 and #2 are used for wastewater disposal/percolation and did not appear to have been disced in the last year (Photos 11, 12, and 15). The EWMP states that percolation areas should be disced, every year, to a depth of 18 inches to ensure percolation.
- 3) Accumulated solids were observed in Lagoon #1, #3, #4, #5 and Pasture #1 (Photos 9, 11, 12, 13, 14, 16, and 17). The EWMP directs that lagoon solids should be removed every summer to ensure full capacity of in the lagoons before the start of the next winter season.

Photo 3: Corral #10 is located at the southeast corner of the facility, view looking east. Corral #10 appeared to be graded so that wastewater would flow south and away from Lagoon #1 (general location circled).

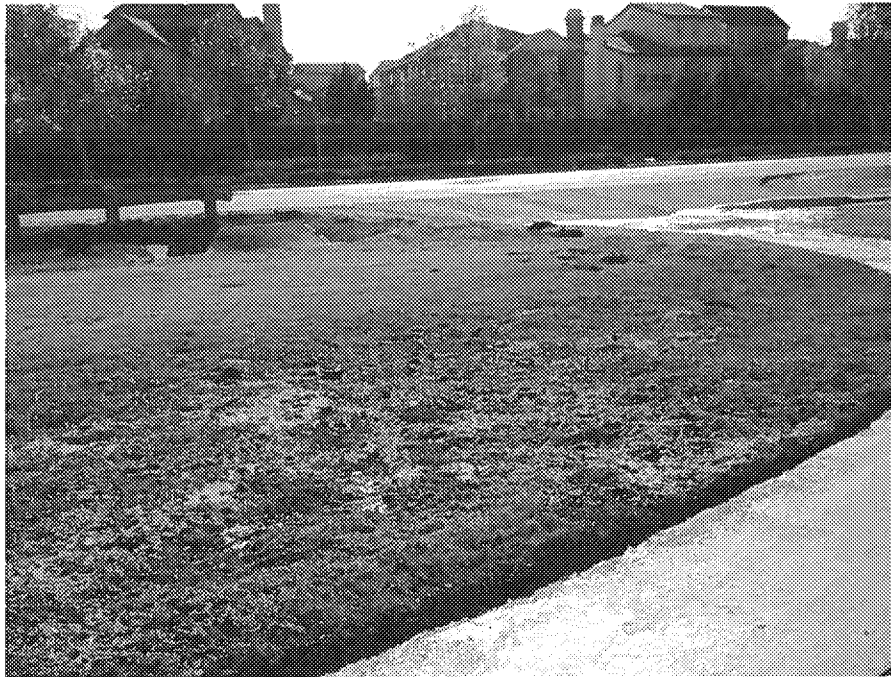
- The facility representative stated that impoundments are cleaned every three years, approximately, but did not remember the date of the most recent cleaning.
- Solid manure and wastewater were observed on the grassy area between the milk barn and Kimball Avenue (Photo 4). This area is not contained and drains to Kimball Avenue.
- During the inspection workers were scraping and piling corral manure for off site removal (Photo 10).
- Manure piles of undermined age were present in Pasture #2 (Photo 15).
- Accumulated manure and ponded wastewater were present at the northern end of Pasture #1 (Photo 11 and 12).
- Improperly stored or disposed chemicals were not observed during the inspection.

Photo 4: The inspector observed what appeared to be manure and wastewater on the grassy area between the milk barn and Kimball Avenue. Runoff from this area flows into the road ditch along Kimball Avenue.

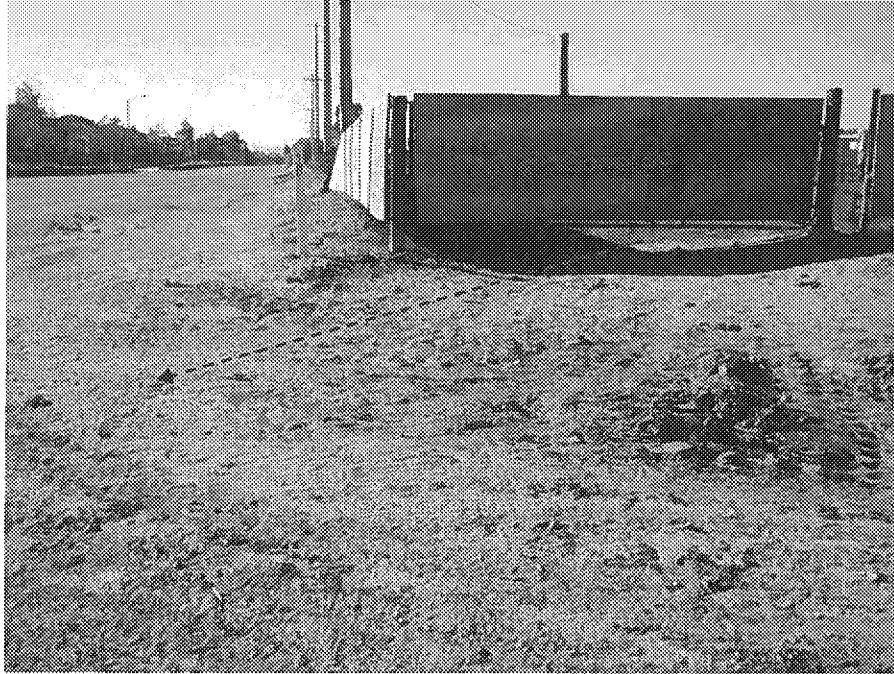
Photo 5: Runoff from Corral #9 could flow under the gate and reach the road ditch along Kimball Avenue. The EWMP directs that Corral #9 be regraded to contain wastewater on site.

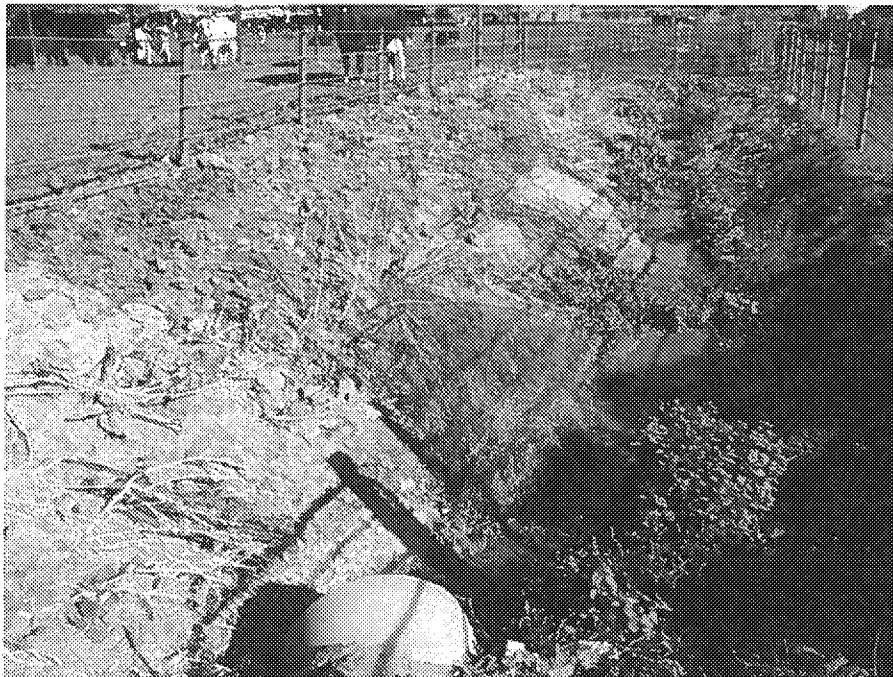
Wastewater was being conveyed to Lagoon #1 through a ditch at the time of inspection (Photo 6). Excess water from pastures is contained by berms at the down gradient end and can be pumped to one or more lagoons. Lagoon #1 is connected to Lagoon #5 by a channel cut into a common berm between the two lagoons. Lagoon #5 has an emergency spillway (GPS coordinates N 33.96890, W 117.61663) to Kimball Avenue (Photo 16).

Photo 6: Milk barn wash water was flowing to Lagoon #1, view looking east.

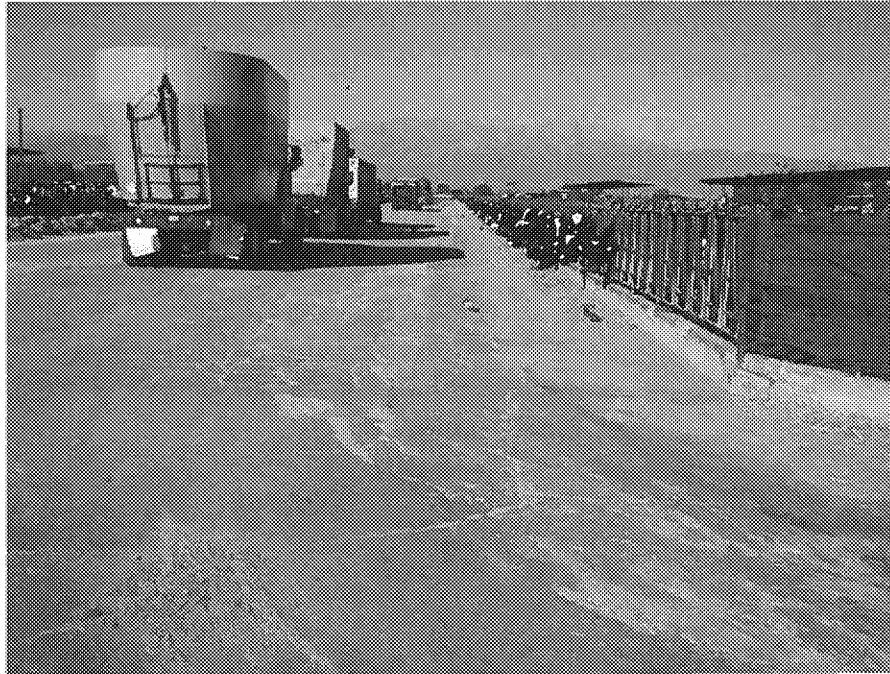
Photo 7: The feed lanes were generally free of spilled feed, manure, or other solids; view looking north.

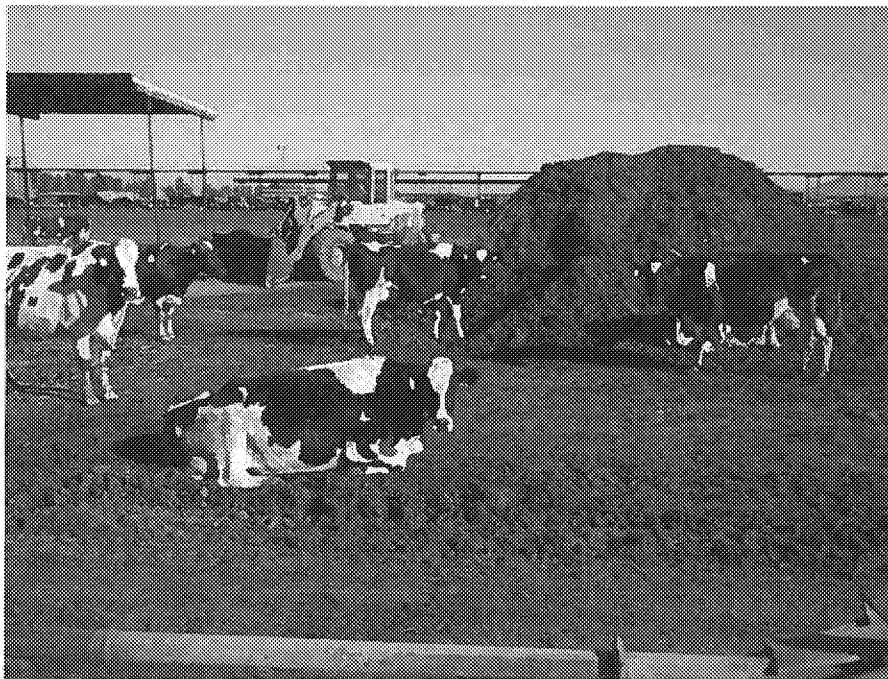
Photo 10: Manure piled in a corral that was being cleaned. The heavy equipment pictured was being used to clean the corral at the time of the inspection.

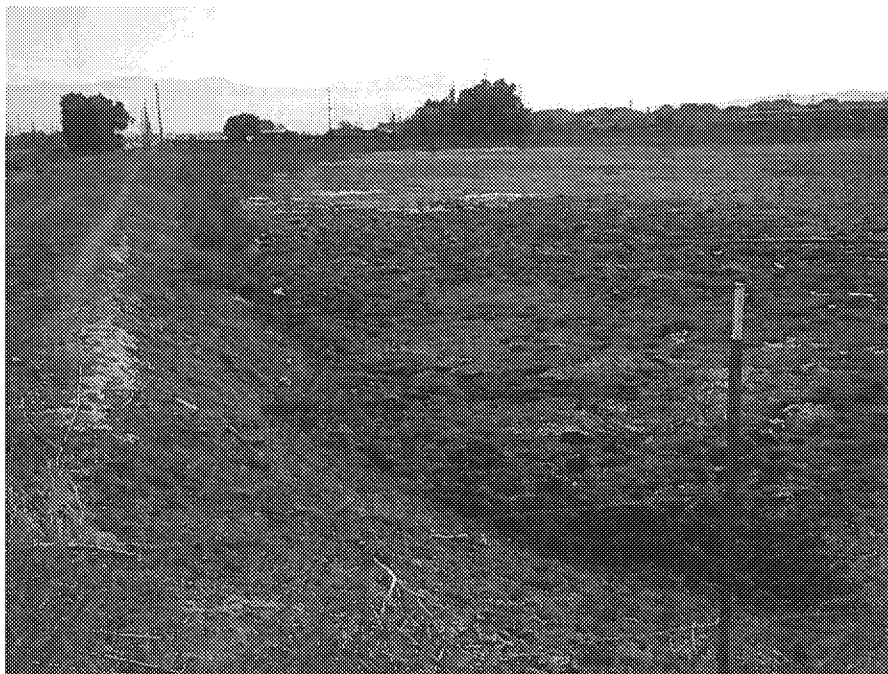
Photo 11: View looking south toward Pasture #1. Manure appeared to be accumulating at the pasture's northern end. The dairy's eastern berm is pictured on the left.

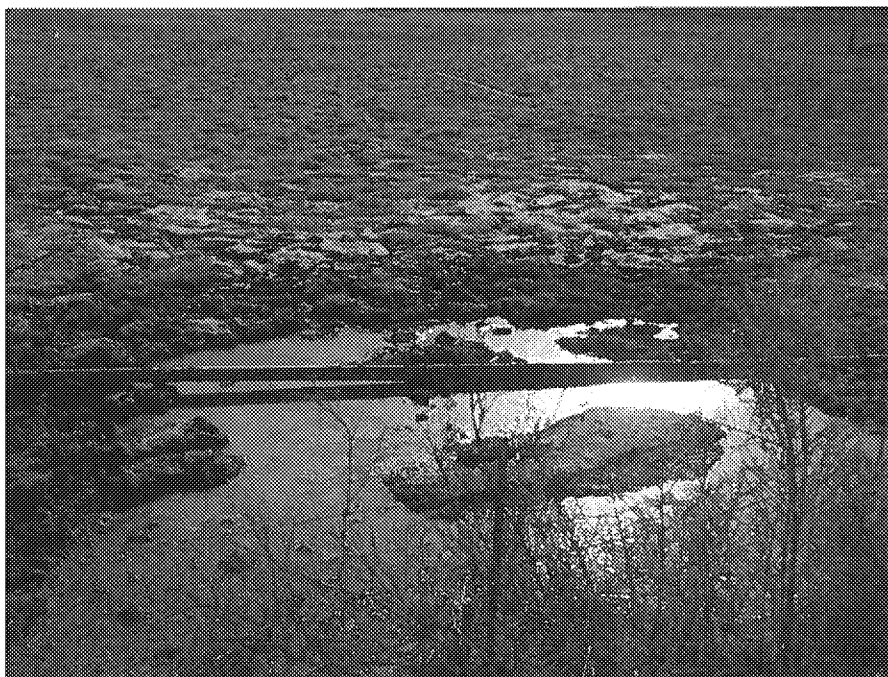
Photo 12: View of accumulated manure and ponded wastewater in Pasture #1.

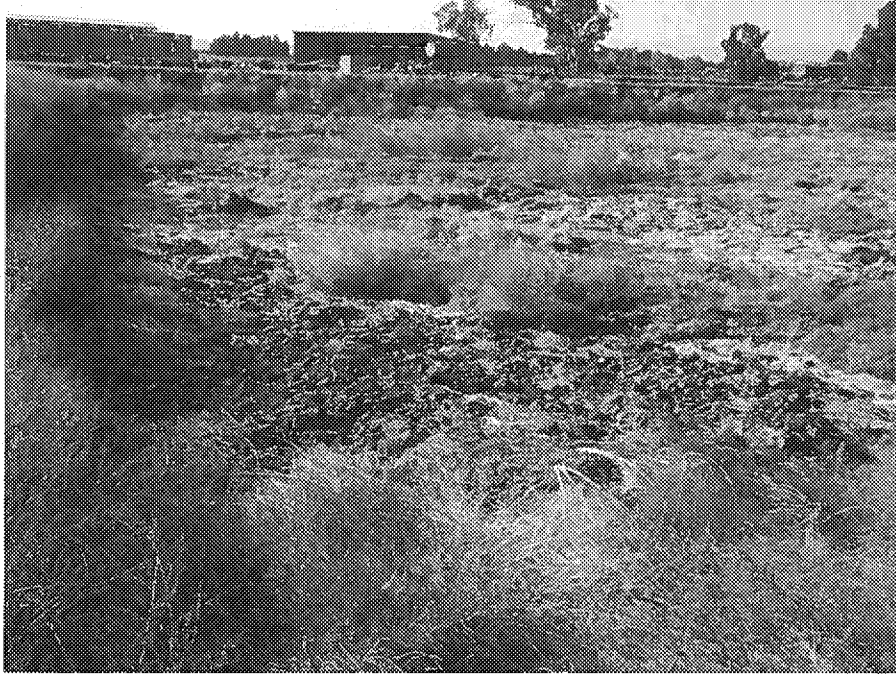
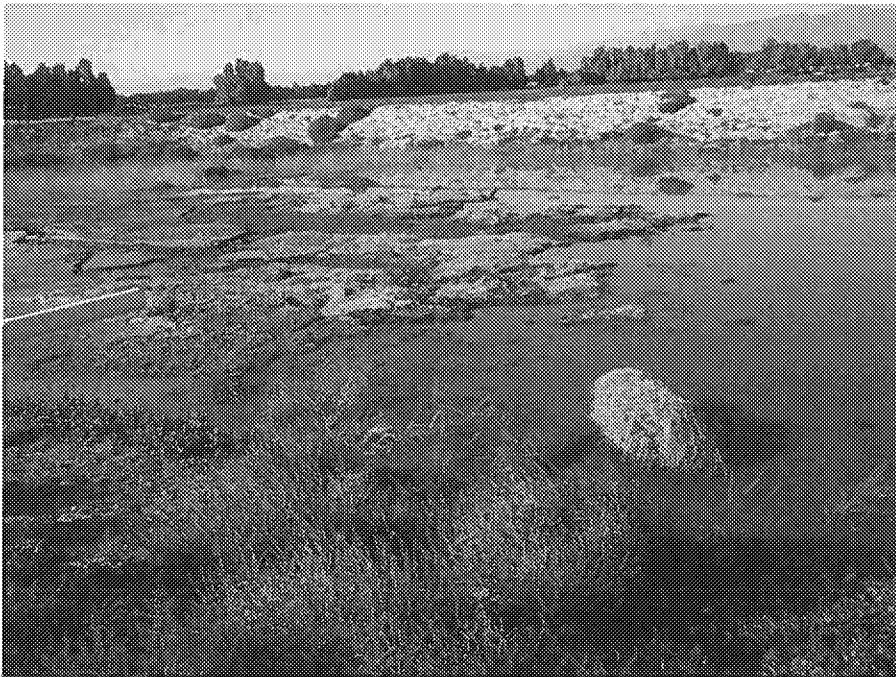
Multiple lagoons contained rodent holes and excessive vegetation (Photos 13 and 14). A gap in Lagoon #5's northern berm (Photo 18) potentially reduces the available storage capacity in this lagoon. This gap was also noted in the 2008 Santa Ana Regional Water Quality Control Board inspection.

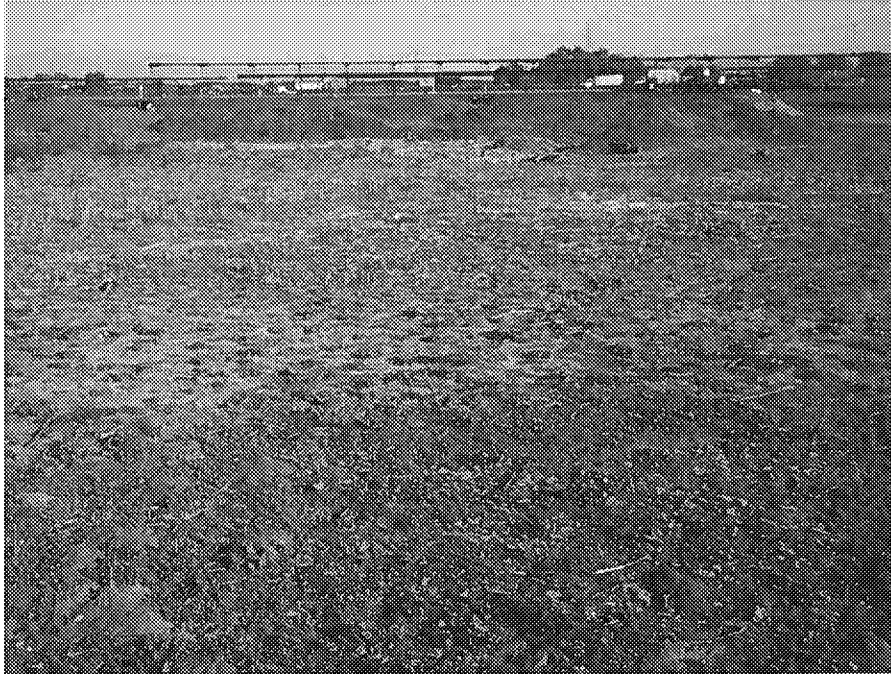
Photo 15: View looking southeast toward Pasture #2. Note the manure stockpiles in the background.

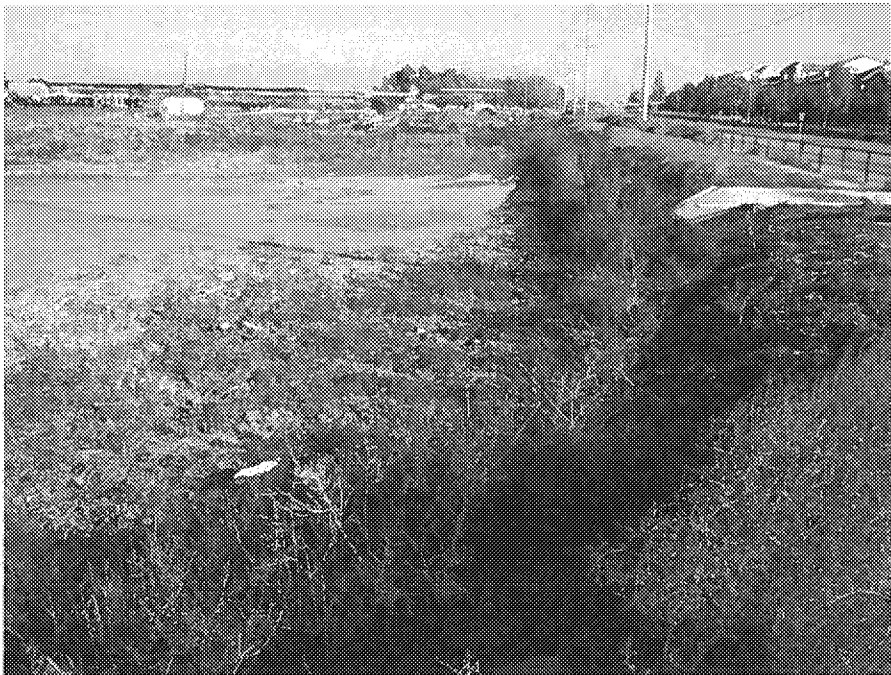
Photo 16: View looking east at Lagoon #5. The emergency spillway from Lagoon #5 to Kimball Avenue is visible on the right.

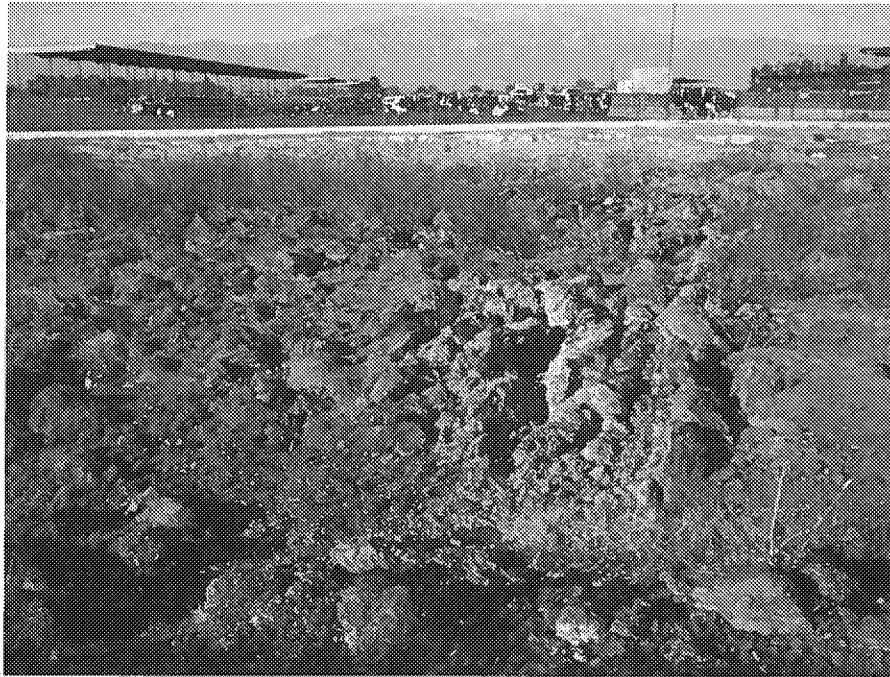
Photo 17: View of accumulated solids in Lagoon #1, looking north.

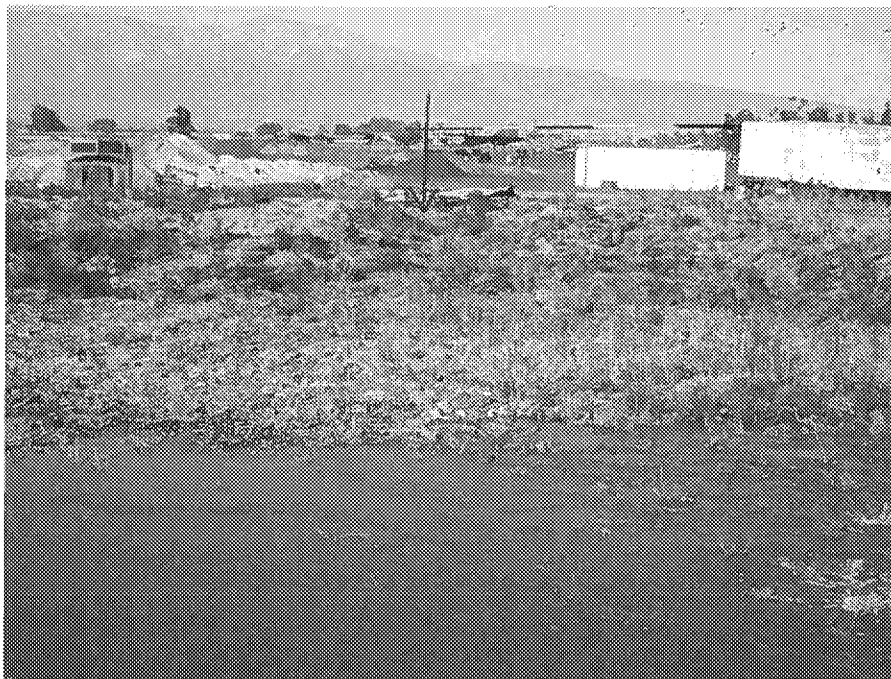
Photo 18: View of cut in northern berm of Lagoon #5.
